## ***Ducted Systems Technical Services Service Letter***

Letter: **YS-001-2020**

Subject: **Blower motor location in belly-band – Regal Beloit Ensight® Blower Motors**

Product: **TM8X, TMLX, TM9X, TM9E, TM9Y, RGF19\*E, RGF29\*E, RGF1L\*E, RGF2L\*E, MM9E**

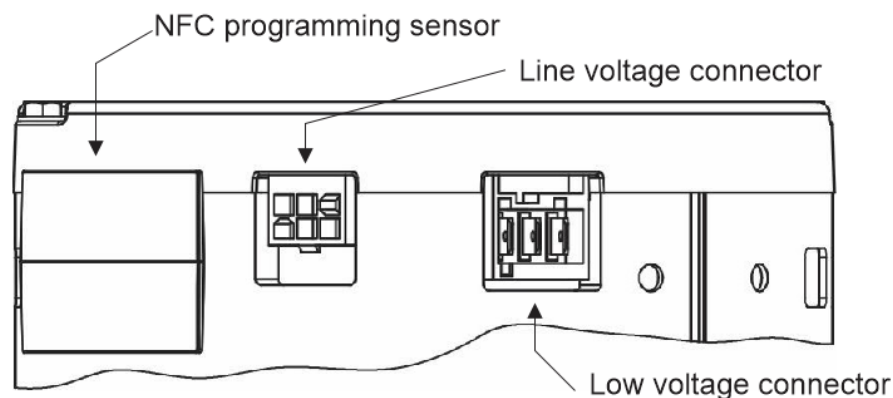
During 2019 some furnace blower motors have been changed from Regal Beloit EnduraPro® motor to the Regal Beloit Ensight® motor as the EnduraPro® is being phased out. The Ensight® motor has several unique features to differentiate it from the EnduraPro®. The motor is lighter in weight, has better performance, can be programmed using NFC (near field communications) and the electrical connections are on smaller simple connectors in lieu of individual speed tap connectors. The Ensight motor can be easily identified by its unique electrical connections. An image of the Ensight motor connections is shown below.

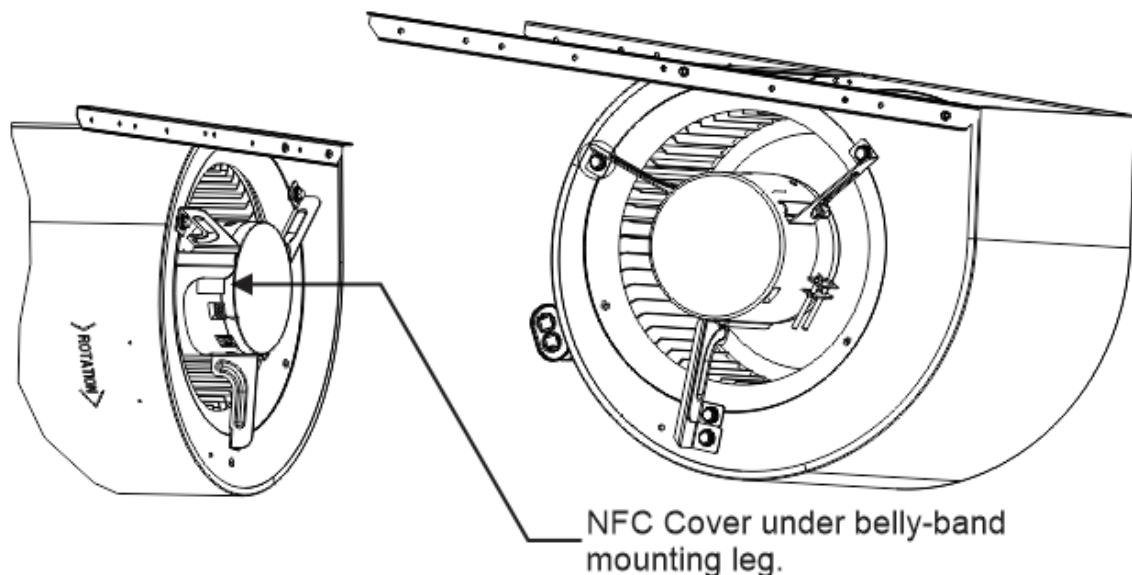
Another reason we found causing excessive blower motor noise is related to some of the motors not being installed correctly in their belly-band mounting assembly during furnace production. The Ensight® motor has a white plastic cover over the NFC programming sensor as shown in the image above. In some cases, the motor belly-band must be relocated/repositioned on the motor. Shown below is an assembly drawing of the motor, belly-band and blower assembly. Notice that the NFC cover is under one of the belly-band mounting legs. When the belly-band is in this position, the motor is not square with the blower assembly and this can lead to excessive noise.

commissioning, the blower motor should be checked to identify if it is an Ensight® motor and then if so, position of the motor in the belly-band as described above. If the motor is in the incorrect location, slide the blower assembly from the furnace, re-locate the motor in the belly-band and re-install the blower assembly. Take external static pressure readings and adjust blower motor speed per the unit installation manual. If excessive external static is present, the customer may need to make duct system modifications.

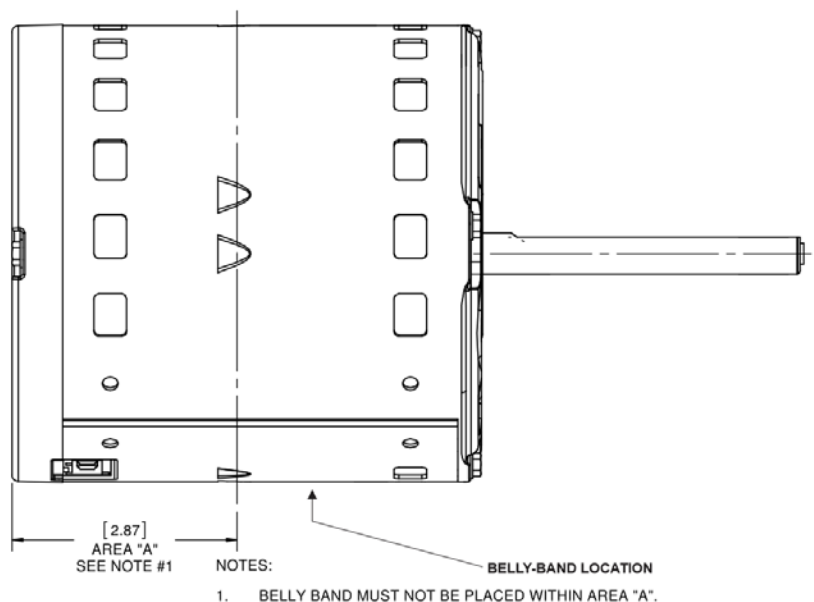
For ½ and ¾ horsepower motors, the belly-band is in the correct location in relationship to the end of the motor (location shown in the image to the right) but the motor must be rotated so that the NFC and electrical connections are in the area where the belly-band clamp bolts are located. Shown below is an assembly drawing of the blower assembly showing the blower motor NFC cover and electrical connections after the motor has been rotated in the belly-band. Notice the connections are in the section of the belly-band where the clamp bolts are located.

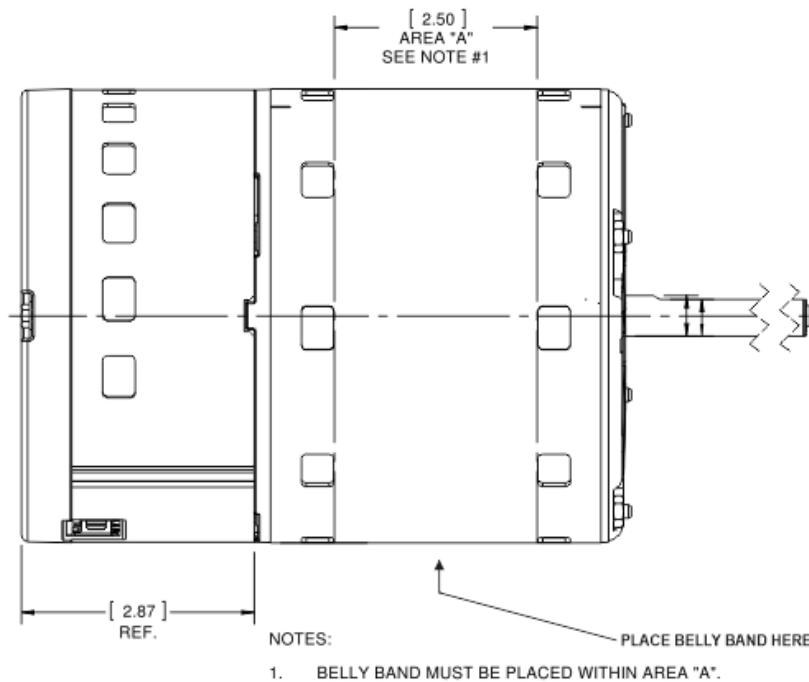
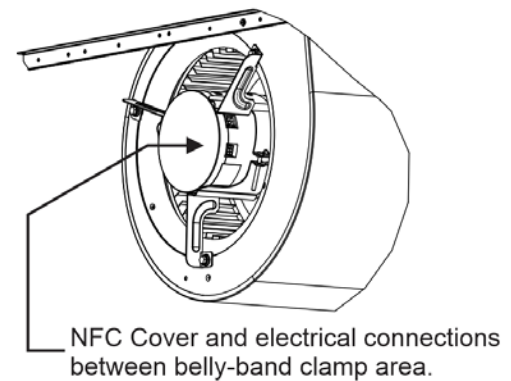
For 1 horsepower motors, the belly band needs to be adjusted so that it is within the appropriate area on the motor. The belly-band must be adjusted toward the shaft end of the motor. Reference the image below showing the correct location of the motor belly-band. The belly-band must be moved into area “A” as shown below.
