***Ducted Systems
Technical Services
Service Letter***

Letter: **YS-002-2021**

Subject: **Blocked suction process tube / Suction access port on Heat Pumps**

Product: THE, YEE, TE4B, REP14L, YHE, TH4B, RHP14L, YHG, CH6B, TH6B, RHP16L, YZT, HC19B, and HL19B

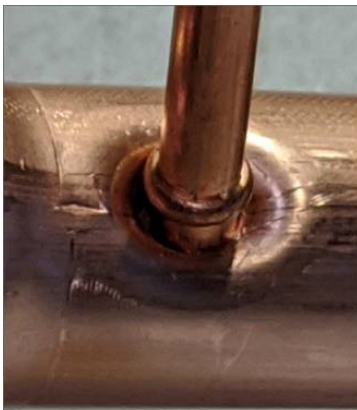
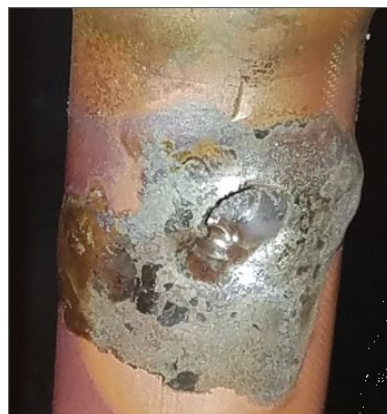
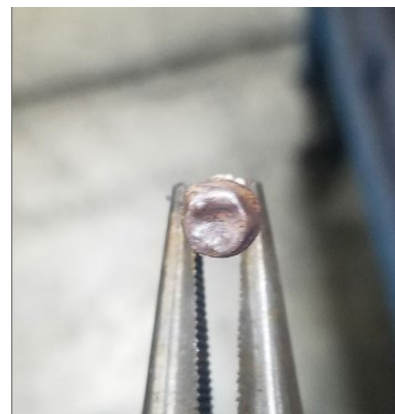
Our internal investigation revealed that the suction process tube was being brazed shut during unit build. It was determined the cause of the error was an improperly created hole in the suction line tubing where the process tube is inserted prior to brazing. Specifically, the hole appears to be pressed instead of drilled which created a "pool" as shown in the image below. During process tube brazing, on some units, the process tube would fill with brazing alloy completely sealing it off from the refrigeration circuit. On units brought back to the factory for investigation when we removed the suction process tube the suction line itself remained sealed with a "slug" of brazing alloy. See images below of sealed suction line and slug of brazing alloy removed from the suction line.

Since the currently installed suction process tube cannot be safely removed and re-inserted at the same location due to the excessive amount of brazing alloy, we have developed a kit that contains 3 different sizes of a pre-drilled copper couplings as shown to the right, replacement suction process tube, bi-flow liquid line filter drier, cable ties, and installation instructions. The field repair kit is part number S1-37347211001. The blocked suction process tube will remain installed in the unit but rolled back behind the unit block off panel and secured with a cable tie. The copper coupling and replacement suction process tube will be installed in a different location between the reversing valve and compressor. Specific locations are called out in the kit installation instructions and a few examples of the copper coupling locations are shown below.
