***Ducted Systems
Technical Services
Service Letter***

Letter: **YS-004-2019**

Subject: **16 SEER Heat Pump MOC (Fan Drive) Control Board Failure**

Product: **Residential YHM, CH16 & TH16 16 SEER 3 ton Heat Pump models**

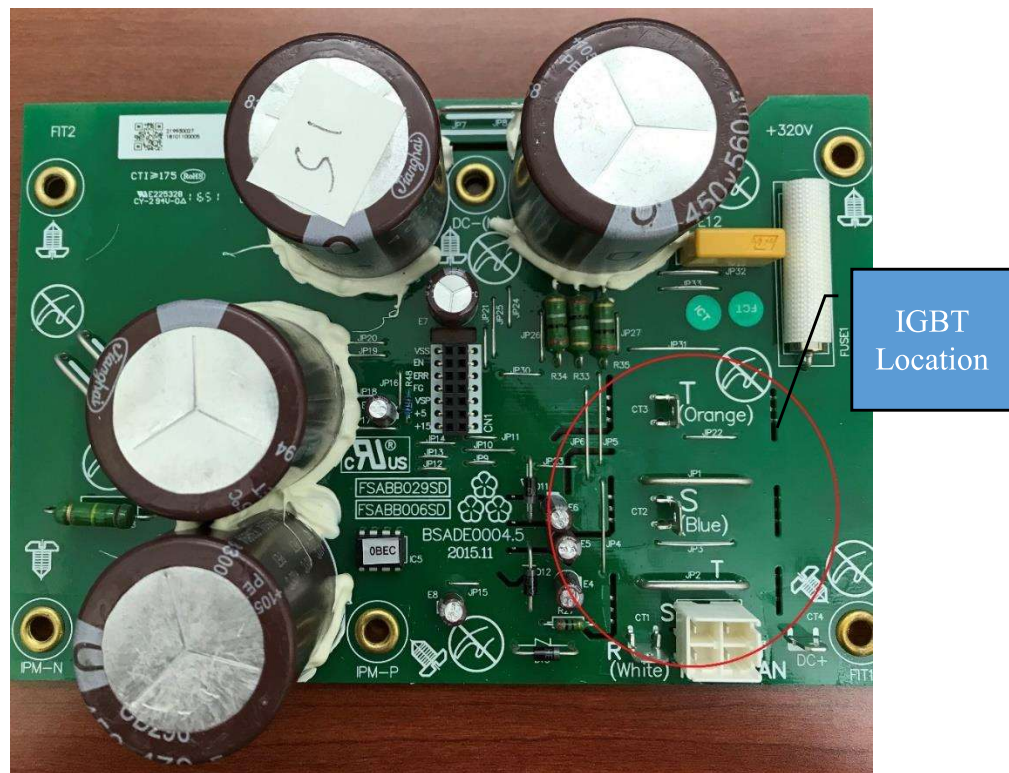
Original Single Sided Board

The pictures above show the location of the IGBT's which are actually located on the back side of the control board, but the physical difference between the two boards is visible from the front. Note the elimination of the slots through the control board as well as the difference in the mounting pads for the IGBT's.
