Date: March 04, 2014

YS-007-14

Subject: 13 SEER, 5 Ton MicroChannel Coil Leaks
YCJD, TCGD, TCJD & GCGD Units.

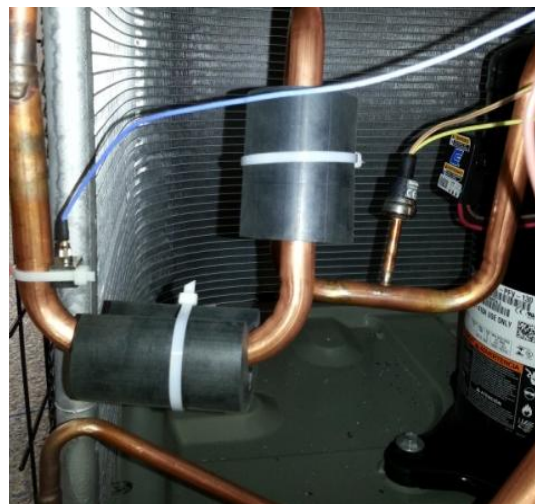
We have received reports of refrigerant leaks occurring at the copper to aluminum connection on the above referenced units. Investigation has confirmed the issue to be at that location, however, the leak is due to a fatigue crack in the copper tube – not the copper to aluminum joint.

As discussed at the fall Tech Conference, our engineering group determined a resonance frequency from the compressor to be the cause for the issue. The compressor vendor was changed in August 2012, which corresponds to the production dates of units experiencing this issue.

Our engineering group has worked with the vendor and determined that adding weight to the discharge line dampens the effect of the resonance frequency and eliminates the issue. For field installed units, we have set up a kit in Source 1 that will provide two 120 gram weights that should be installed on any 13 SEER, 5 ton units referenced above in the locations shown in Figure 1. The kits can be ordered from Source 1 beginning in March under part number S1-37327978001.

We recommend that field installed units referenced in this service letter that have not experienced a leak at this location have the Source 1 kit installed during preseason check-ups. This service letter will allow one hour labor credit, plus the cost of the kit.

Units that experience a leak in this location will need to have the coil replaced and the redesigned discharge tube installed to prevent future issues. This service letter will allow the standard 4 hour labor allowance for subject units that are beyond the 30 day DOA labor allowance for replacement of the coil and redesigned discharge line, plus refrigerant. Please refer to this service letter when submitting a warranty claim for either installation of the Source 1 kit or replacing the coil and discharge line. The redesigned discharge line is available from Source 1 under part number S1-07327984001.
