YS-010-10

SUBJECT: Fan Grill Rattling on Predator 6.5 through 12.5 ton Units.

UNITS: DF078-120, DH078-150, ZH078-150, DM078-150, DR090-150, ZR078-150, BA-078-150
XP078-150

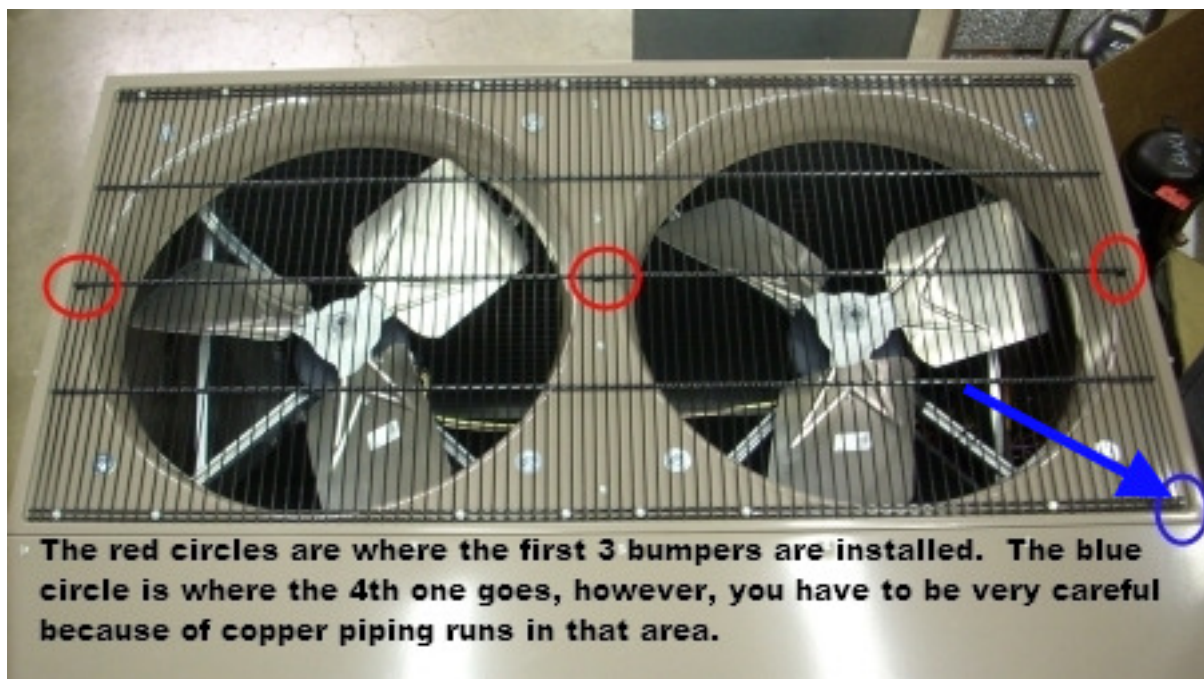
These units were originally designed with a two piece grill covering the condenser fans. Starting October 15, 2007 the fan grill was changed to a one piece design. The original design was to have an arc in the grill to prevent rattling when secured.

Stacking and shipping of the grill would diminish the fan grill arc, allowing the grill to rattle when the fan was running.

The fan grill is secured with screws except in the 4 places where these bumpers are used. See below.

The three locations marked with a red circle are not a problem. The area beneath the deck is clear.

The location marked with the **blue** circle in the lower right of the above picture is critical and should be approached carefully. **Refrigerant piping is located in that area.** You will need a 3/16" metal drill bit with a depth limiter when drilling the hole in the corner location. If you do not have a special bit with a depth limiter, then you can cut a piece of copper that fits over the bit, allowing only about 1/8" of the bit to be exposed. Or, you could use duct tape to wrap the bit four or five times to expose only the 1/8" of bit. **DO NOT TRY TO DRILL THE HOLE WITHOUT SOME TYPE OF DEPTH LIMITER.**

DAMAGE TO COPPER LINES COULD RESULT.

After receiving some reports from the field, we looked at many ways of stopping the fan grill from hitting and making noise. November 12, 2009 (4) "bumpers" made of urethane nylon were added to the fan deck at strategic points. This stopped the rattling and noise.

The bumper, S1-02815890000, is available from source one and can be field added to units making noise from a rattling fan grill.

If you have a listed unit manufactured between 10/15/2007 and 11/12/2009 with the once piece fan grill, you can add these bumpers to stop the fan grill from rattling.

You will have to drill 4 - 3/16" holes in the locations shown. Mark the hole location prior to removing the fan grill. The large diameter cross bar will rest on top of the bumper.

Once you have marked the location of the holes to be drilled, remove the fan grill.

Drill the holes and insert the bumpers. Re-install the fan grill. Turn disconnect back on and verify operation of the unit.
