**YS-025-11**

**Subject:** Issues with No Fault Light on Ignition Board, Failure to Ignite Pilot

**Units:** 3 – 6 Ton Small Sunline Package Units

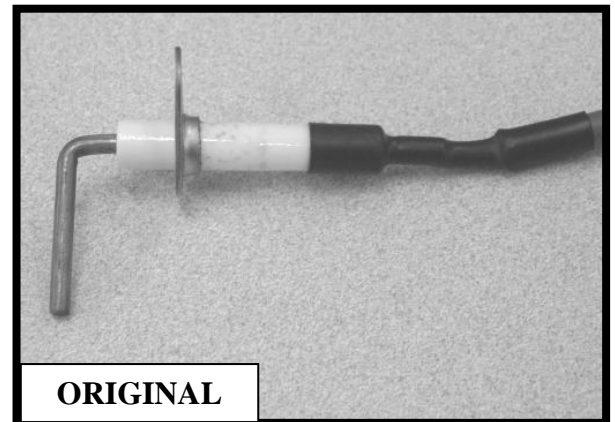
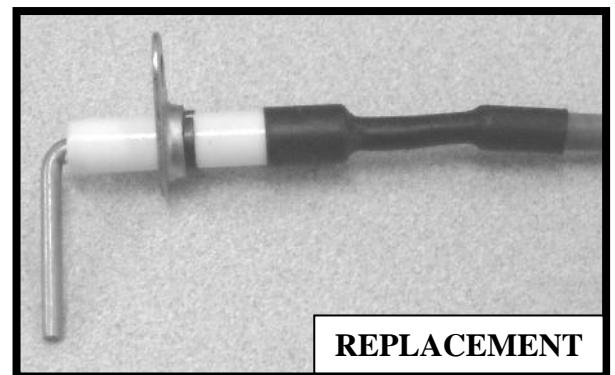
Investigation concluded that the igniter was producing erratic spark. The spark should be from the end of the electrode to ground to ignite the pilot gas. The spark was exiting the probe to any closer ground point, such as the screw used to attach the igniter and surrounding metal pieces. This erratic operation produced electrical noise that affected the logic of the ignition board.

The solution is a new igniter with the extended ceramic and shortening of the screw holding the igniter to .25”, preventing the spark from grounding to the screw.

A replacement igniter kit, part number S1-37331175000, includes the extended ceramic igniter (S1-02646749000 (SAP# 692207)) igniter and a new mounting screw (S1-692208).
