**DATE:** December 30, 2011

**YS-029-11**

**SUBJECT:** Cracked Condensate Pans – All 33” Furnace Models

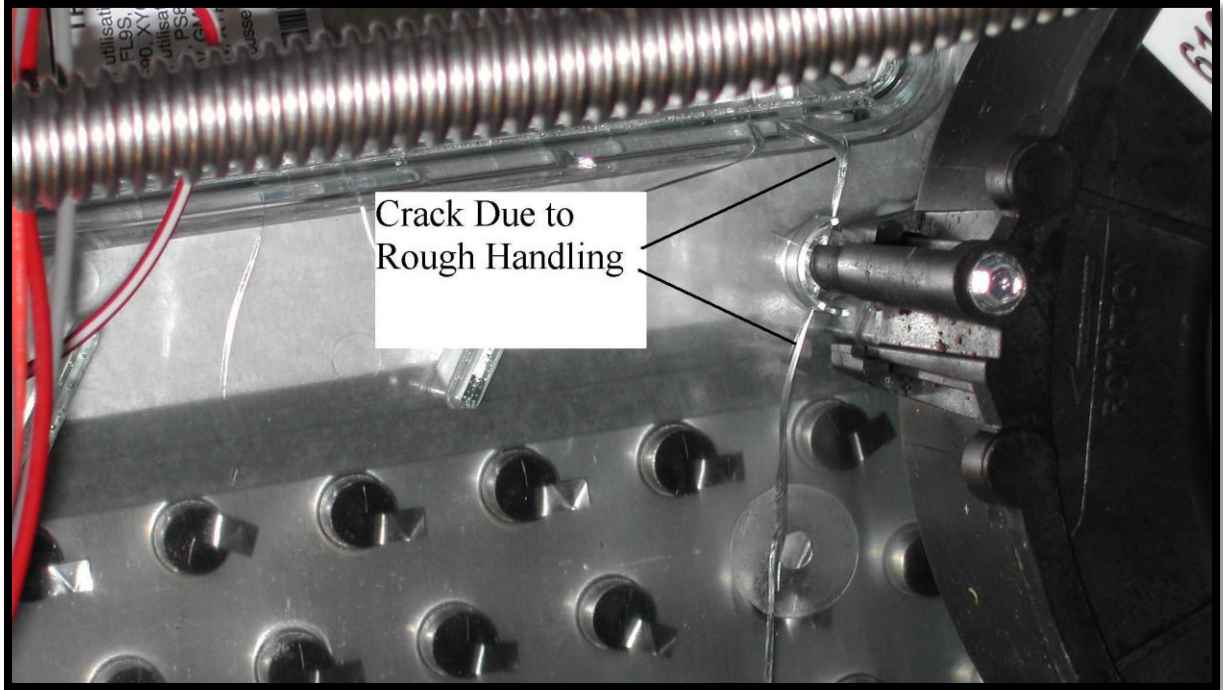
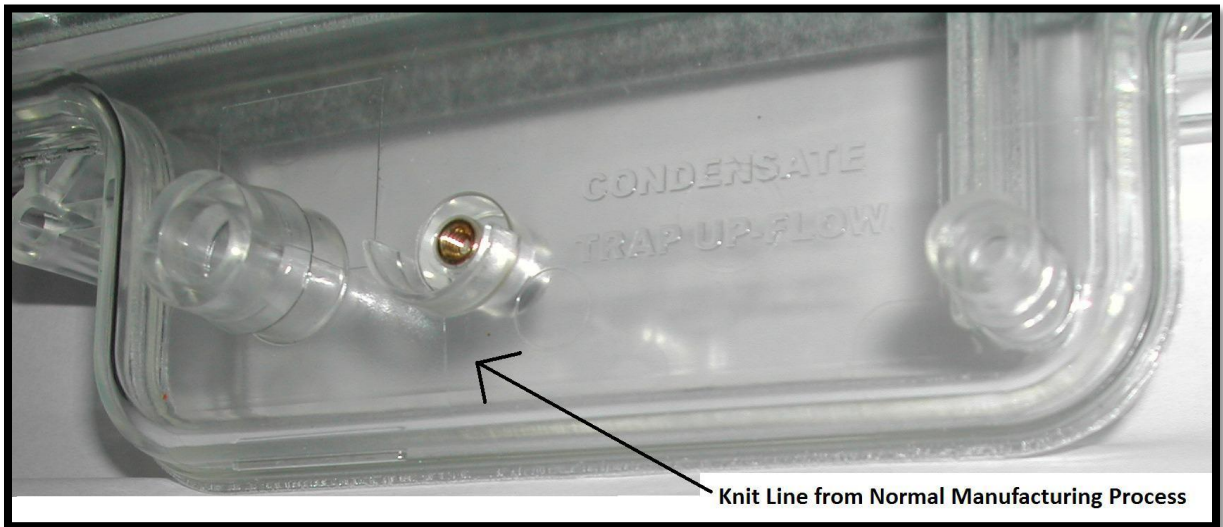
The photos below illustrate cracks typical of two of the three potential failure modes (environmental stress cracking (ESC) and rough handling). Knit lines are part of the normal molding process, are **not** considered a defect, and are **not** a cause of leaks.

This YS letter provides a one hour labor allowance for the replacement of any drain pan with an (ESC) or freight damage/handling crack, subject to the return of the drain pan. Record the serial number of the furnace the pan was removed from in permanent marker on the face of the pan. If the serial number is not written on the pan, we will not be able to match it up against the claim and approve the labor.

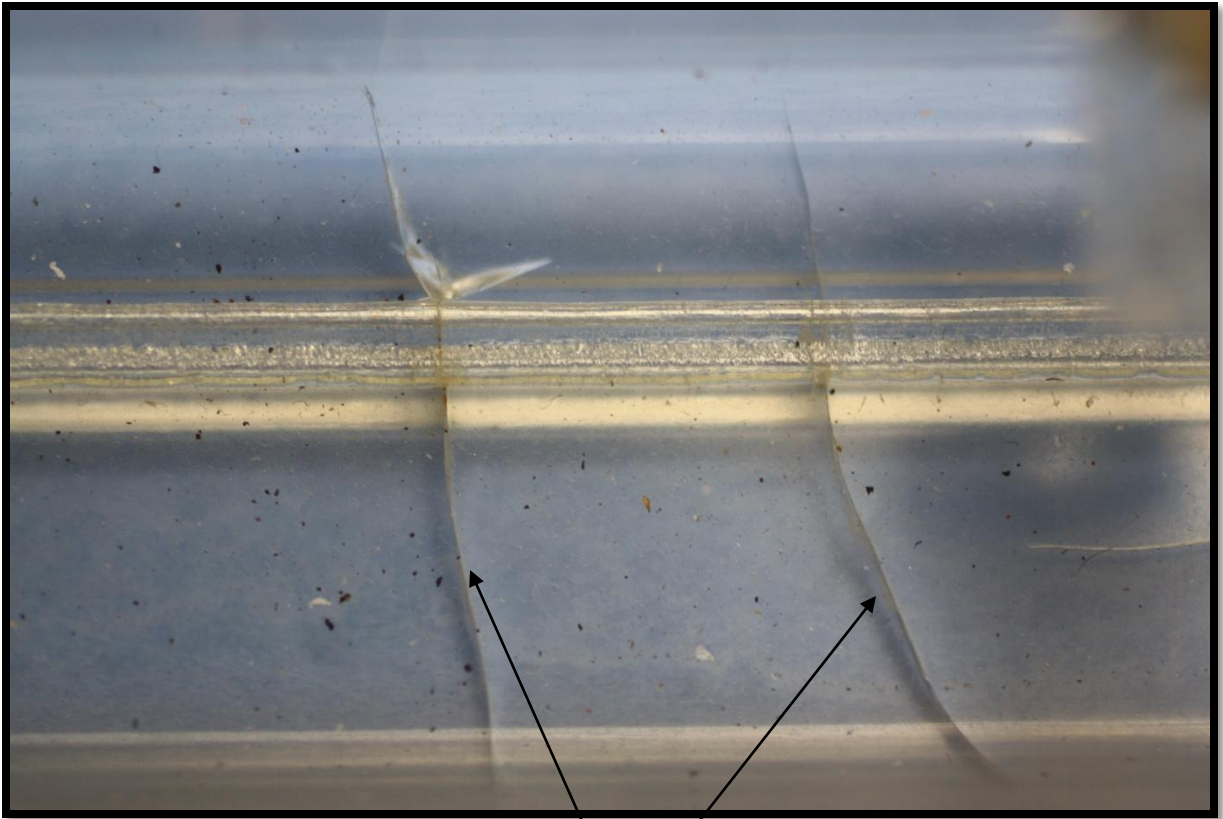
Environmental Stress Cracks (ESC) on Seam of Pan

ESC is the premature initiation of cracking and embrittlement due to contact with specific fluids. The characteristics of ESC failures are shown in the image above, with cracks initiated at the seam and moving perpendicular to the line. Such ESC can be initiated by chemicals such as:

If you observe ESC, please collect detailed information regarding the chemicals used at the site and forward to your Unitary Products technical representative. This will help us determine prevalence of specific fluids causing the cracks.
