## SERVICE INFORMATION

**YS-051-08**

**Subject: Pressure Switches YP9C, YM9M, TG9S & GG9S**

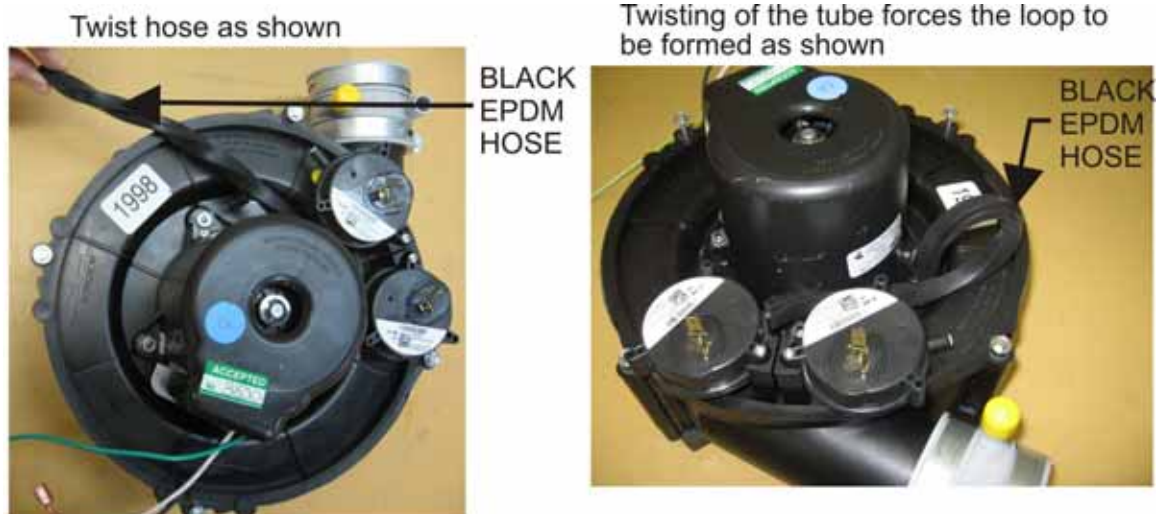
- 5) Make sure that the blocked condensate pressure switch hose (Figure 1) is connected to the correct port on the condensate pan. If not, the condensate pan can fill with water allowing it to enter the inducer, which may cause the furnace to shut off. Refer to the installation instructions and/or the Quick Reference Guide for proper hose connections.

Figure 1: New routing of the EPDM hose in all single-stage furnaces as of 11/17/2008

To improve the robustness of the furnace, we have made a change in the routing of the main pressure switch black square hose that connects the main pressure switch to the inducer on all models. This change was made effective on November 17, 2008. The new routing will ensure against any water getting into the pressure switch from the inducer, regardless of furnace orientation. See attached photo (Figure 1). This routing can be duplicated in the field to alleviate this issue by using a field-supplied 9 inch length of 3/16" tubing. Twelve inch lengths are available through Source1, P/N S1-02815878000. This will also eliminate the need for the field practice of physically moving the pressure switch to a higher location inside the furnace.

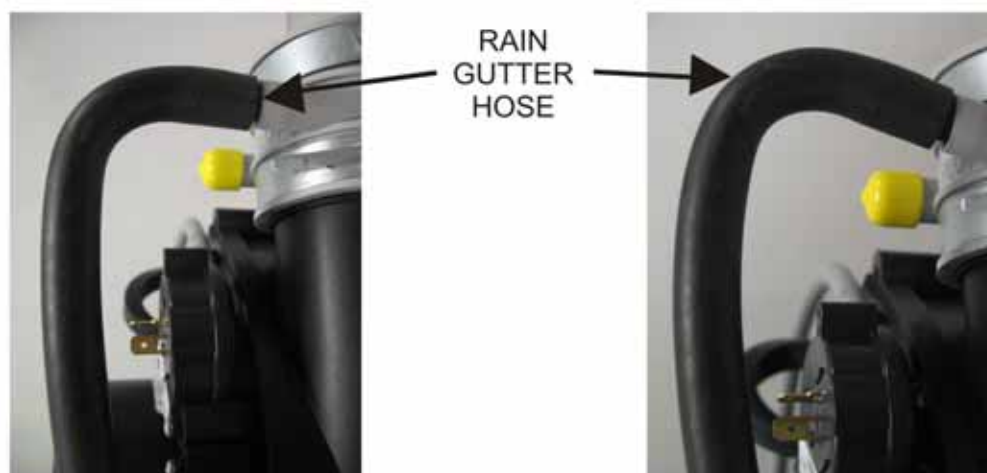
Figure 2: Correct Rain Gutter Hose Routing

Figure 3: Incorrect Rain Gutter Hose Routing

- the condensate pan itself. It is always good practice to deburr both the inside and outside of all cuts in the PVC piping.
- 2) Check that the rain gutter hose runs downhill from the rain gutter to the condensate pan. In cases where the inducer has been rotated due to application, the rain gutter hose may have to be trimmed in order to accomplish this. See Figures 2 and 3 for reference.

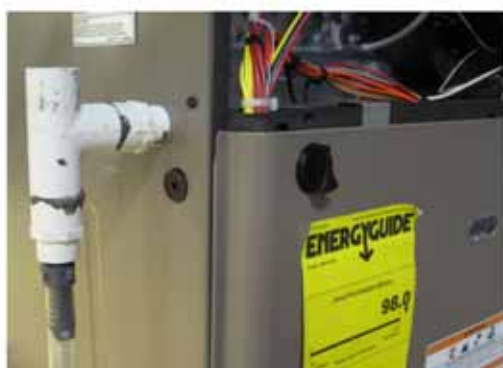
Figure 4: External Short Drain Tee

- 7) The external condensate drain line attached to the furnace cabinet will flow better if an open tee is installed in the condensate line. This is the same as all other plumbing drains in the home. This vent needs to be approximately the same height as the internal trap. Reference Figure 4 for proper height and location.

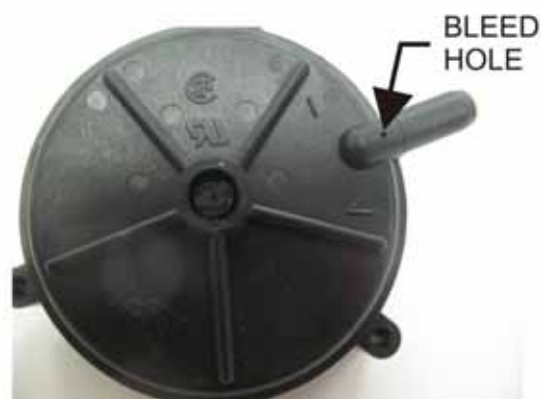
Figure 5: Pressure Switch

- 8) Ensure all unused ports on the condensate pan are capped to prevent internal traps from being formed.
  - 9) Make sure that the bleed ports on the pressure switch have not been covered over by any of the pressure switch tubing when installed, as that may result in improper operation of the furnace. See figure 5 for bleed port location.

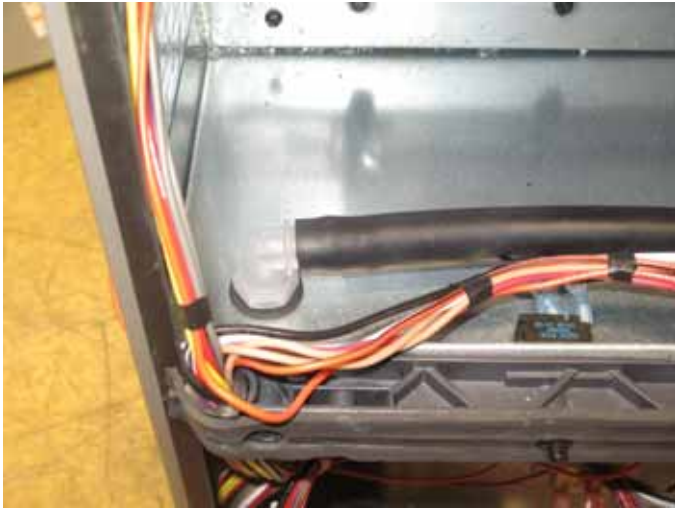
Figure 6 – Proper sealing for blower deck penetration

- 10) Do not make any penetrations through the blower deck. During the cool-down of the furnace the combustion blower will shut down and the circulating blower will continue to run. During this time, the negative pressure from the circulating blower can pull moist air back through the vent system and pressure switch tubing by way of the pressure switch bleed hole. The only time penetrating the blower deck is allowed is for the drain hose provided it is properly sealed using the factory provided right-angle hose fitting and O-ring (see Figures 6 and 7). All other wiring or accessory connections should be made through the sides or back of the casing. This also prevents any water that could be on the blower deck from following the path of the wires directly to the control board or any other electrical components.

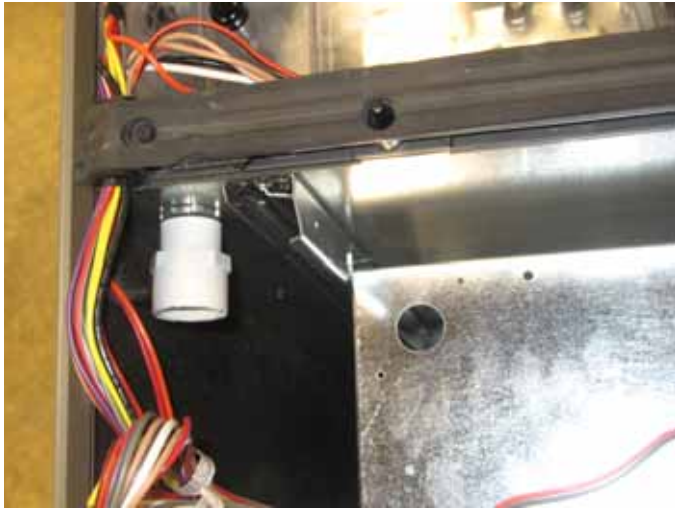
Figure 7 – Proper connection for blower deck penetration
