**Date:** May 18, 2015 YS-SP007-15

**Subject:** 33" 80% & 90% Gas Furnace – Therm-O-Disc Limit Switch Recall

**Issues:** Suspect Limit Switch

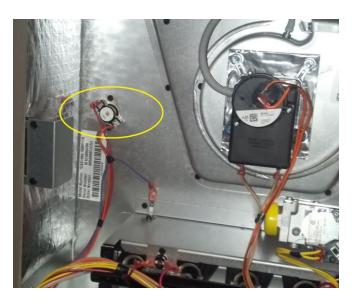
We were recently notified of a testing issue at our supplier's location with certain limit switches used on the above referenced furnaces. One of their testing stations was not operating properly and passed all switches that were tested for a five week period. Switches involved are part numbers \$1-02541320000/356207 & \$1-02541321000/356208. The switches involved have date codes of 1511 through 1516. It is important to note that not all switches produced with these date codes are defective; however, since these switches serve as a safety device which could result in a potential safety issue, we are requiring replacement of all suspect switches.

Limit switch location on 80% furnace

Suspect units already installed must be remediated in the field by replacing the limit switch. This service letter provides a one hour labor allowance for replacement of any of the limit switch part numbers referenced above and which falls within the suspect date code range of 1511 through 1516. Make sure to reference this YS-SP service letter number on the claim.

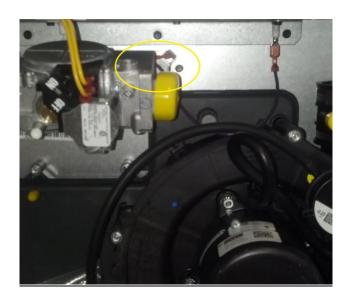
Below is a sample picture of the limit switch and where the date code is located. We also have pictures showing where the limit switch is located on both the 80% and 90% gas furnaces. Note that the limit switch on the 90% models is behind the gas valve.

Limit switch location on 90% furnace
