***Ducted Systems  
Technical Services  
Service Tips Letter***

Letter: **ST-007-2018**

Subject: **Condensate dripping issue with Residential Early production model CM indoor coils applied in a horizontal application.**

Product: Residential CM Model cased coils: AP, AE, AVC, RFCX\*\*22 air handling units.

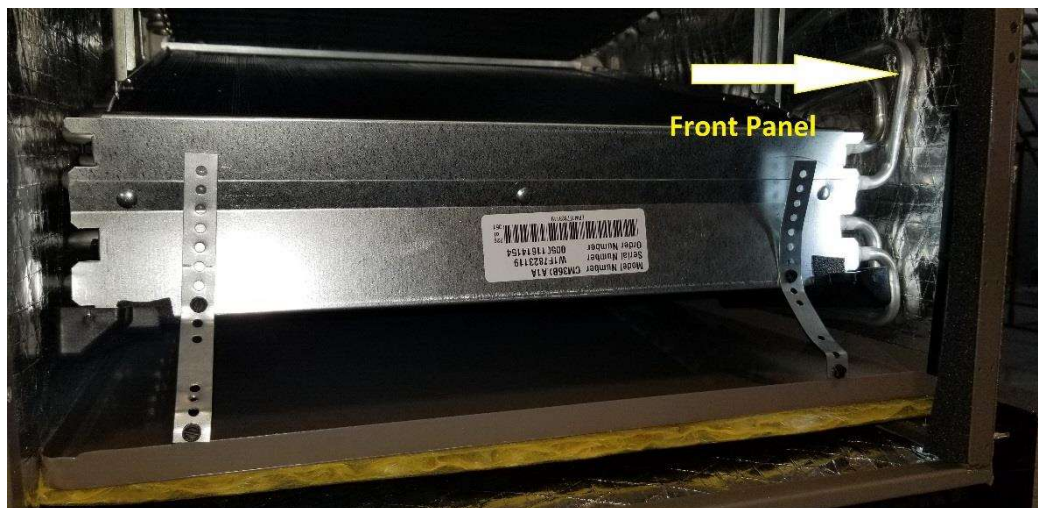
Through our investigation, we discovered that the distributor assembly, tubes, suction header and TXV body of the coil may be pressing against insulation of the front panels of the coil case, which is shown below.

When condensation is formed during normal operation, the condensation has the ability to make contact with the insulation face and travel down the foil surface. Due to the design of the first generation horizontal drain pan, the drain pan may be unable to capture all of the condensation coming off the front of the coil.

Based on these findings, Design Engineering implemented a wider horizontal condensate drain pan in July of 2017. The drain pan can be identified by the edge connected to the horizontal pan straps. The first generation drain pans had a 45-degree edge. The current drain pan has a 90-degree edge. The drain pan edge was changed to improve condensate management within the pan. Shown below is a picture of the current drain pan that now has an interference fit with the insulation on the back coil cabinet and front panel. Coils produced in August 2017 (W1H7) and later contain the new wider drain pan.

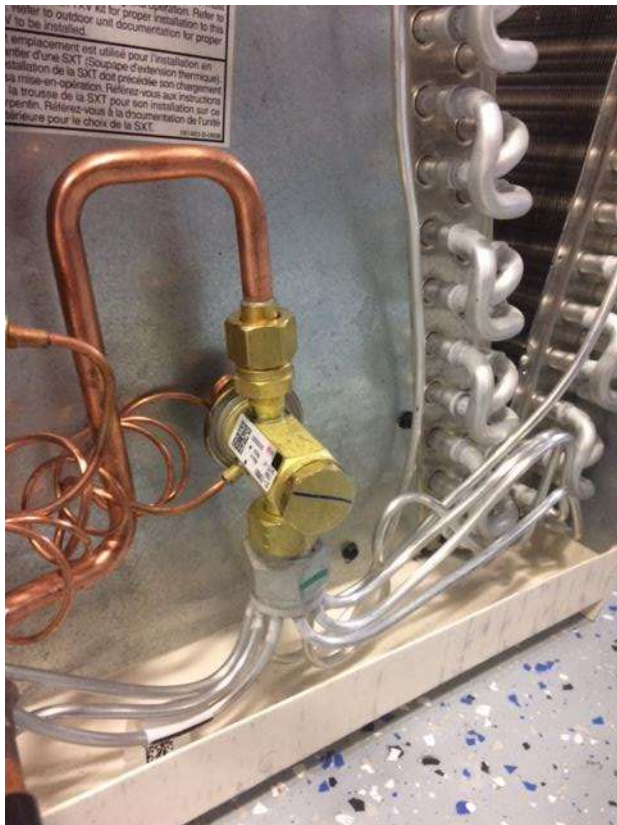
Another issue that may lead to condensate not managed properly, is the installation of the TXV to the distributor body. The improper orientation or position of the TXV can allow it to protrude into the insulation on the door panel. This may cause the condensate on the foil surface to drain around the pan. When installing the TXV, make sure that the TXV body is oriented parallel to the delta plate as shown in the unit installation manual. See photos below.

**INCORRECT INSTALLATION**

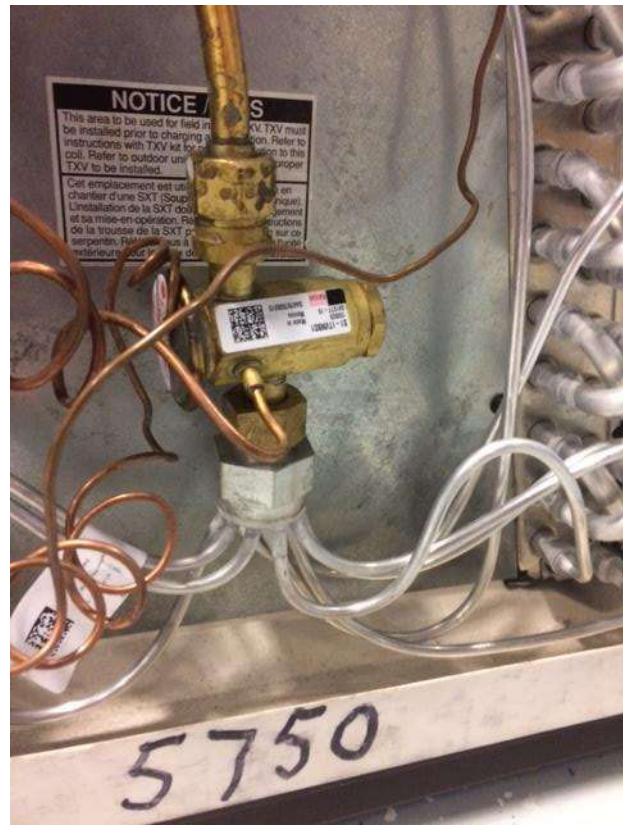
**CORRECT INSTALLATION**
