***Ducted Systems  
Technical Services  
Service Tips Letter***

Letter: **ST-014-2018**

Subject: **3-12 ton Packaged Reheat – Resolution of 3-way valve issue.**

Product: **Series 10, Predator, Outfitter, Ovation, ReliaCore 300, OmniCore 300**

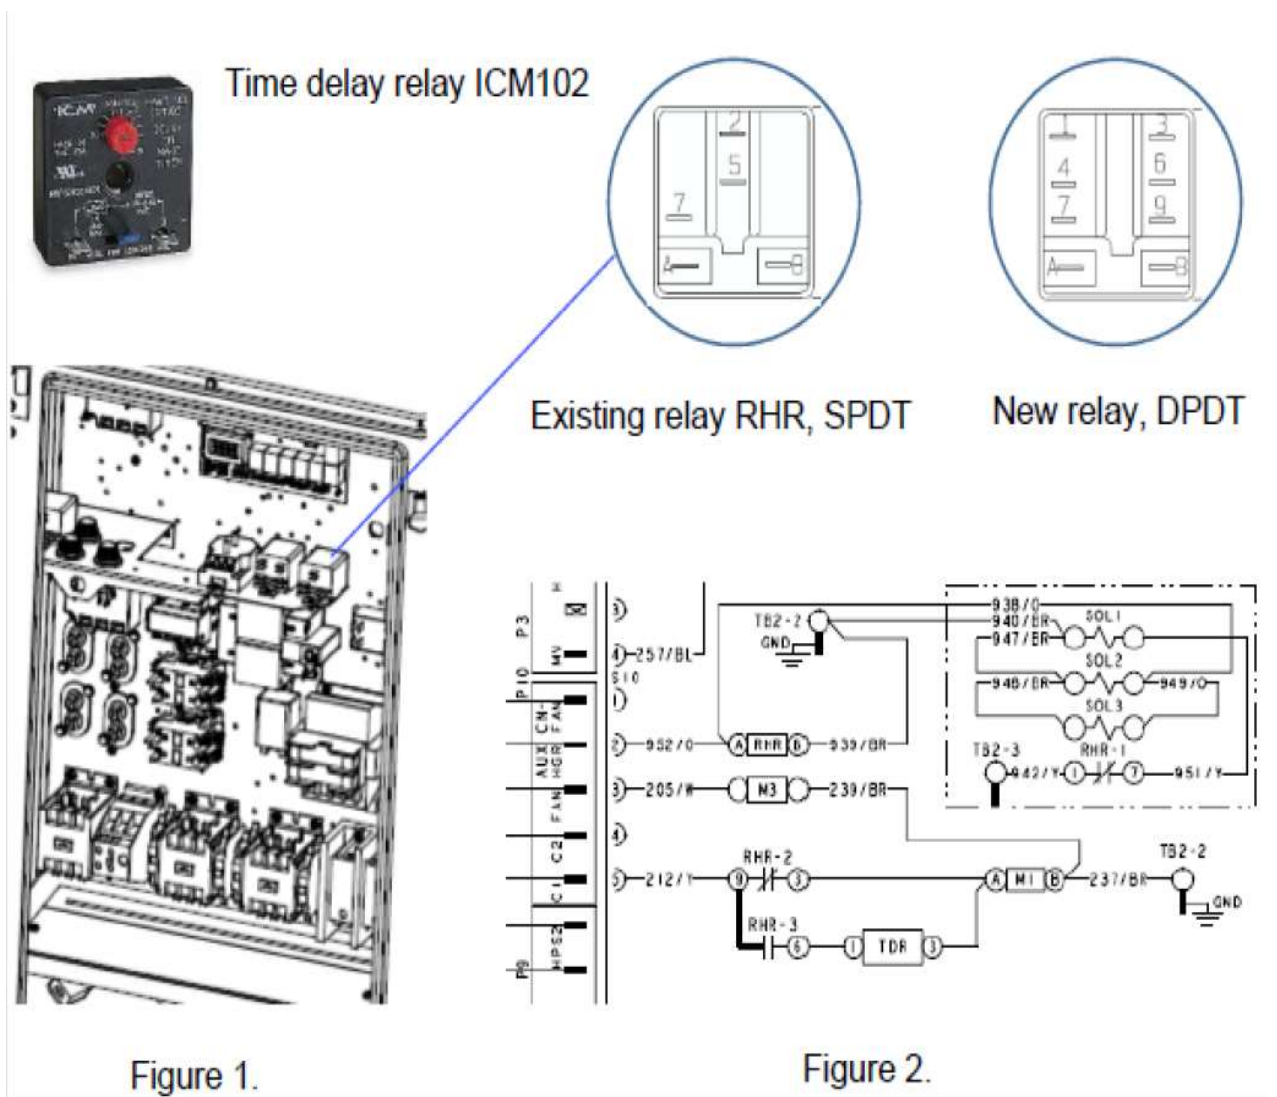
In late summer and early fall of 2018, Technical Services received isolated reports that the 3-way valve on the subject units was not actuating fully to the reheat position. If this occurs hot gas from the compressor during reheat mode will be fed to both the reheat coil and the condenser coil and the condenser coil bleed solenoid will continuously try to recover refrigerant. The symptoms of this condition can be identified as follows:

The following instructions are to provide direction to replace the current RHR (SPDT) with a (DPDT) relay with the addition of a Time Delay Relay. The purpose of this change is to provide a brief interruption of the compressor at the initiation of a call for dehumidification only and allow the Reheat Valve to fully shift to the reheat mode.

1. Open the controls access door and locate the reheat relay, as shown in Figure 1
2. Disconnect all wires from the reheat relay and remove the (2) screws securing the reheat relay. Discard relay

3. Install the new reheat relay DPDT, secure using (2) screws removed from previous step
4. Install ICM102 time delay relay
5. Connect wiring as described in steps 6 thru 13, refer to Figure 2 below as needed

6. Connect wires 938/O and 952/O from UCB-AuxHGR and SOL2 to terminal 'A' on the new RHR relay
7. Connect 939/BR from TB2-2 to terminal 'B' on the new RHR relay

8. Connect 951/Y from SOL1 to terminal '7' on the new RHR relay
9. Connect 942/Y from TB2-3 to terminal '1' on the new RHR relay
10. Disconnect 212/Y for compressor contactor M1-A and re-connect to terminal '9' on the new RHR

11. Connect a new wire from compressor contactor M1-A to terminal '3' on the new RHR relay
12. Connect a new wire from terminal '1' on ICM102 to terminal '6' on the new RHR relay

13. Connect a new wire from terminal '3' on ICM102 to compressor contactor M1-A, since there may be only one terminal available on M1-A, a piggyback terminal may be required

14. The time delay relay ICM102 is adjustable up to 10 minutes. It is recommended to set the red dial to the 2-minute mark
15. After the time delay is set, close the controls access door, restore power to the unit and confirm unit operation
