VAST-003-2014 Service Tip 02/12/2014

**Subject: High Pressure Switch Trips**

Affected Equipment: YHJR (all tonnages) or YHJD (48/60) Heat Pumps

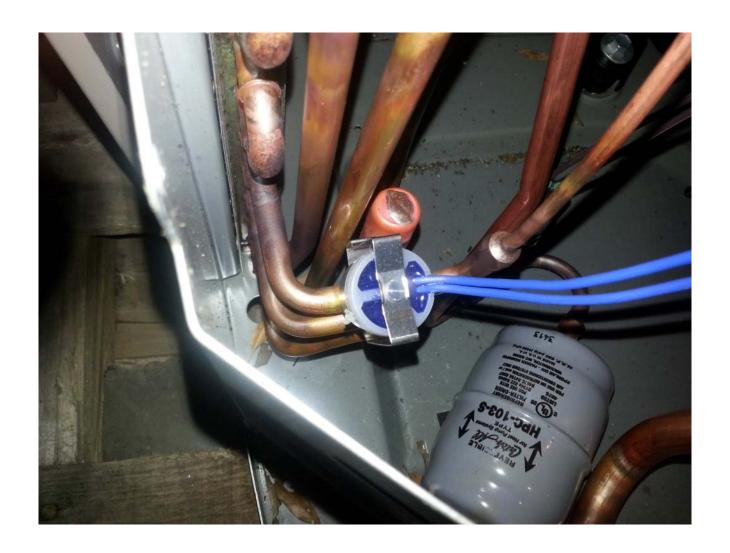
Prior to taking other actions verify the system's refrigerant charge, airflow, metering device and indoor coil match are correct. We strongly recommend this be done by completing one of our startup and data sheets. We also recommend making sure the defrost thermostat is attached and making good contact with the copper. The attached picture shows the proper location of the defrost thermostat.

If the items listed above are correct replacing the 80° defrost thermostat with the 55° defrost thermostat (Source 1 Part # S1-02537482000) should eliminate the high pressure trips, keeping in mind it could result in less than complete defrosting of the coil. At this point we'd ask you to provide us with a completed data sheet so we can report this back to the factory.
