VAST-13-001

Virginia Air Service Tip

06/27/13

Subject: Poor House Ground causing white Flakes and Possible Formicary Corrosion

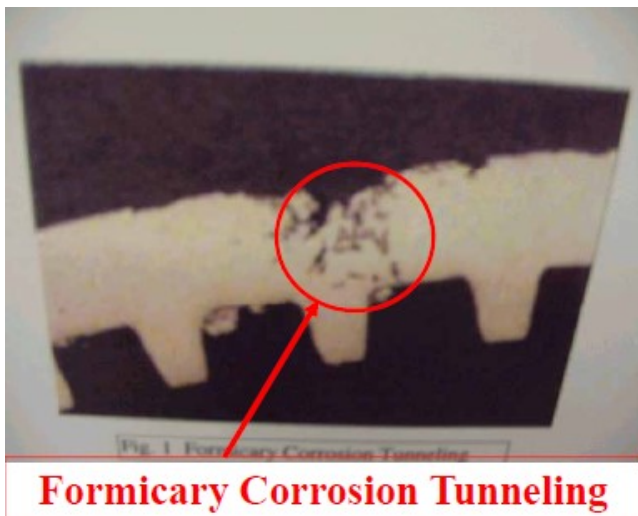
As we all know formicary corrosion of copper tube, aluminum fin evaporator coils is a serious concern for consumers, contractors and manufacturers throughout the industry. Owing to how the impacted copper appears under a microscope it is sometimes referred to as “ants nest corrosion or tunneling”. See figure 1

Figure 1 - Ant's Nest Tunneling

Formicary corrosion is caused by a chemical reaction requiring three parts: oxygen, water, and an organic acid. If any of the three parts are removed further corrosion can be prevented. The most baffling aspect is of this phenomenon is that it does not appear to occur uniformly throughout the country but is found in high numbers in some parts of the country. Studies are ongoing in an effort to identify the cause(s).
