Ducted Systems Technical Services: Service Tips Letter

Letter: ST-010-23

Subject: **Smart Equipment Controllers Unit Control Board Intermittent Issues**

Product/s: Simplicity Smart Equipment (SSE) using a Unit Control Board (UCB) (Norman Manufactured)

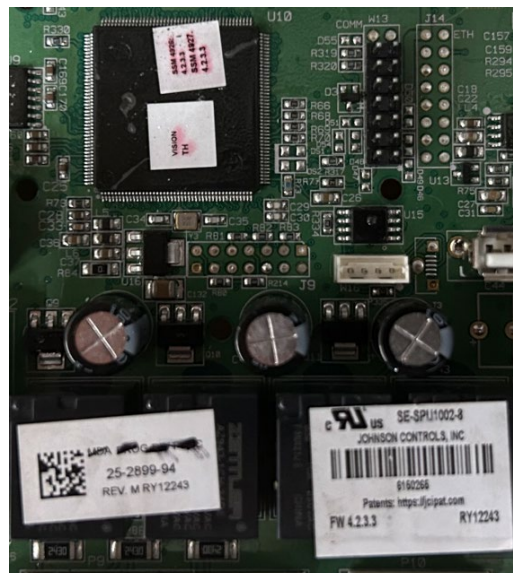
Requested Photo of Stickers Example: (May need to remove communication card)

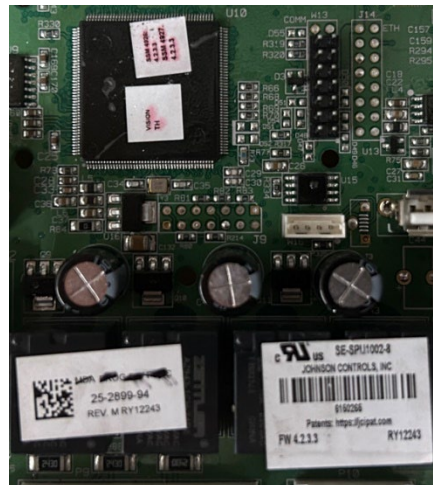
Requested Photo of Stickers Example: (May need to remove communication card)
