Ducted Systems Technical Services: Service Tips Letter

Letter: STR-006-24

Subject: LaB Codes, HMH Series Coil Failures

- Product: HMH72B
- Summary: Johnson Controls has received customer cases that they have encountered 4-ton and 5-ton HMH72B units reported with premature coil leaks.

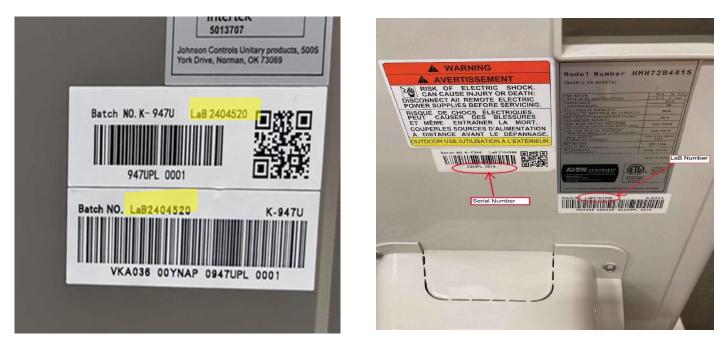
Below are pictures that show the location of the LaB Number and serial number.
