SERVICE INFORMATION

YS-001-05 Expires 12/31/05

SUBJECT: Simplicity control boards failure on 6.5 – 12.5 ton Packaged units

UNITS: DM,DF,DH,DR,DJ078-150

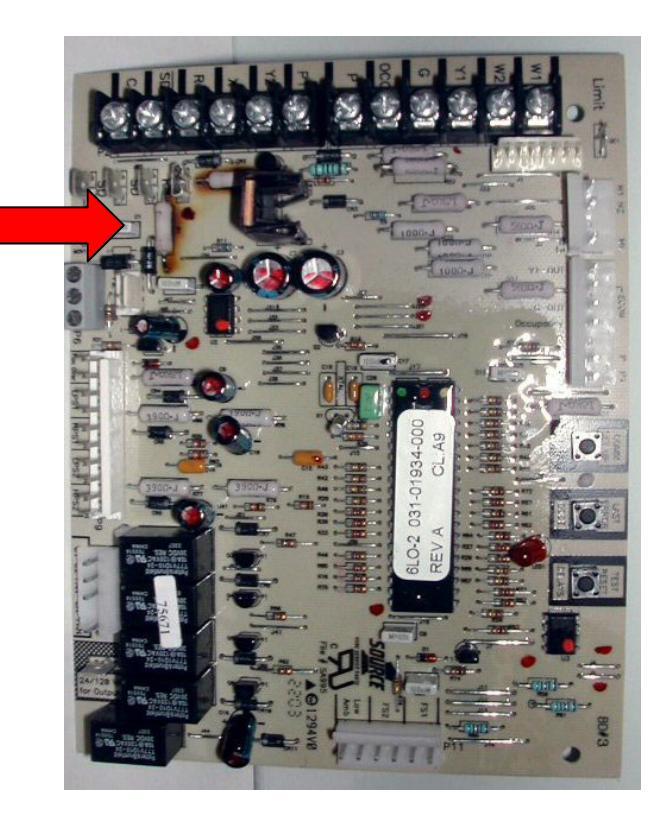
The module failure results in a dead module with loss of cooling, including fan operation. However, firing of the burners will occur on a heat call. You will not have fan operation, causing the unit to cycle on the limit until it locks out. The failure is readily recognizable by looking at the board. Two resistors (R1 & R12) that meet at a 90 degree angle just above the "R" terminal for the thermostat wiring will overheat, discolor, and burn.

This problem only affects the Texas Instruments Simplicity board, 031-01934-000. The Utec version of this board, 031-01934-002, does not have these resistors. The resistors are intended to protect the voltage regulator, but appear to instead amplify another problem.

Texas Instruments: Utec

031-01934-000 031-01934-002

Texas Instruments and the York Control Group have been unable to determine the root cause of the failure. TI thinks it is related to "noise" or a ground issue. So far the problem has not been duplicated in the lab. Without being able to duplicate the cause of the failure, a solution cannot be found. We do know that because of the design differences in the Utec and the TI boards, the Utec board will solve the problem.

York will allow 1 hour at standard warranty labor rates to replace a TI Simplicity board that fails in this manner. Coverage is for the board and labor. File a standard warranty claim and reference this service letter.
