TECHNICAL SERVICE

YS-039-07

Date: July 13, 2007

Subject: Top Panel Screw Penetration Leaks in TCGD& GCGD Unit, Micro-channel Outdoor Coils

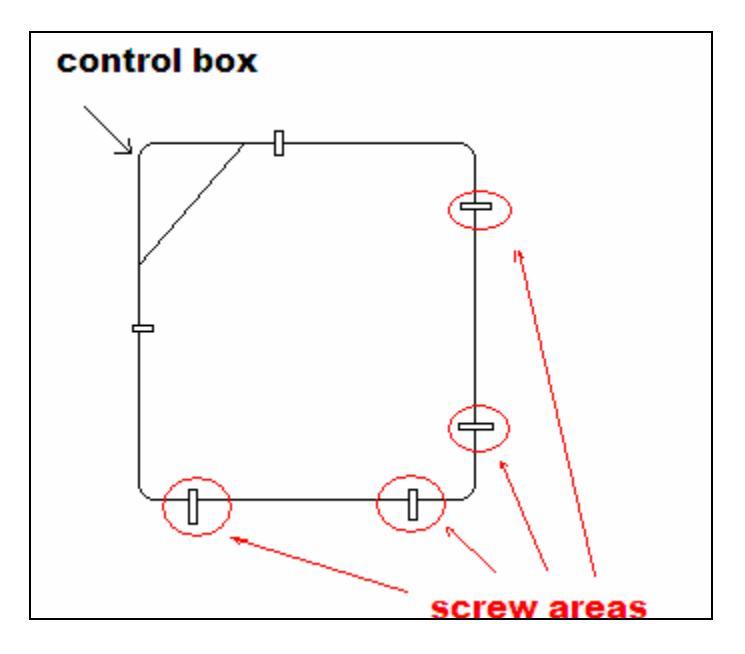
FIGURE1: SCREW LOCATIONS

1.) Inspect the aluminum coil surface at those locations behind the screw attachment points. Refer to Figure 1 for these locations. If the coil is not damaged, continue with Step 2.

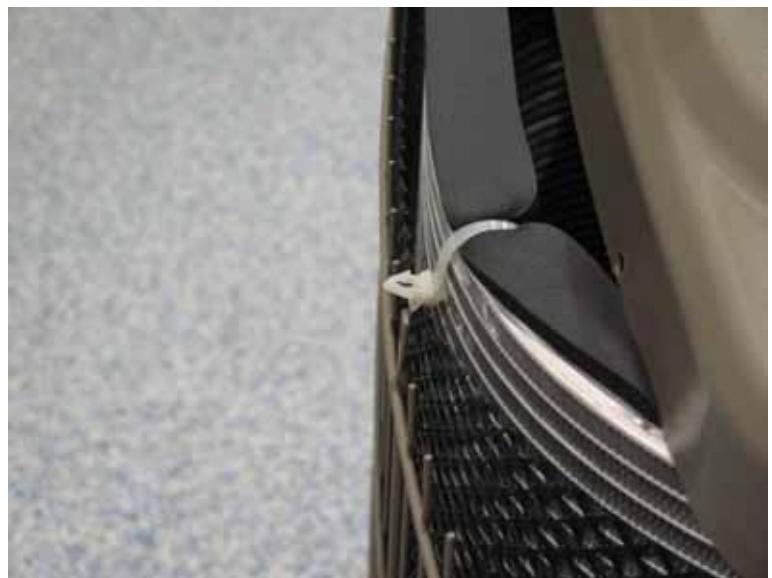
Figure 2: Insert Zip-Tie with Arrow Pointing Away from Unit

- 2.) Remove all screws that attach the metal top to the wire coil guard, control box, and control box cover.
- 3.) Locate area of microchannel coil directly behind screw holes in wire coil guard.
- 4.) Insert zip-tie through the fins 2 to 3 rows down from the top of the coil with the head of the zip-tie toward the outside of the coil (arrow head should point away from the unit). Refer to Figure 2. Arrow head should also press against the inside of the top panel flange when assembled to act as a spacer.

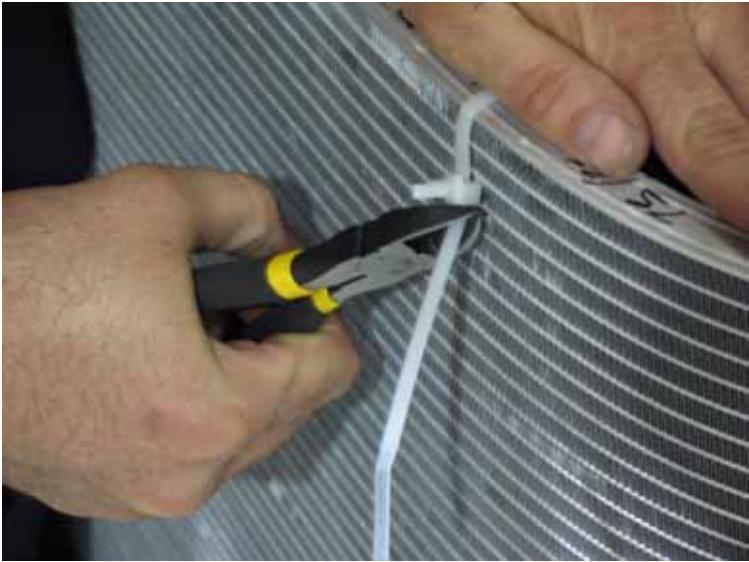
Figure 3: Cut Excess Zip-Tie Material

- 5.) Pull opposite end of zip-tie (should be on the inside of the coil) over the top of the aluminum coil and back around to the outside of the coil.
- 6.) While holding the head of the zip-tie against the aluminum coil, insert the other end of the zip-tie through the zip-tie head and pull until completely tight.
- 7.) Using wire cutters, cut the excess zip-tie material off. See Figure 3.

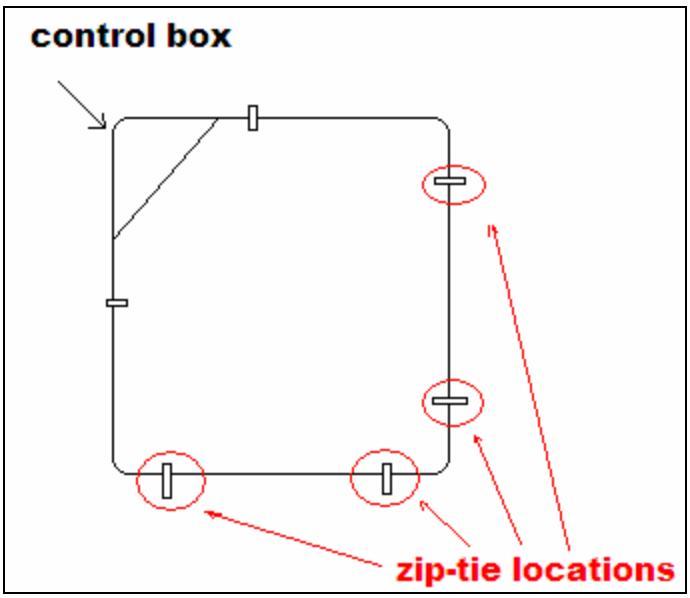
Figure 4: Aerial View of Zip-Tie Locations

8.) Repeat procedure for the remaining 3 screw locations. See Figures 4 and 5.

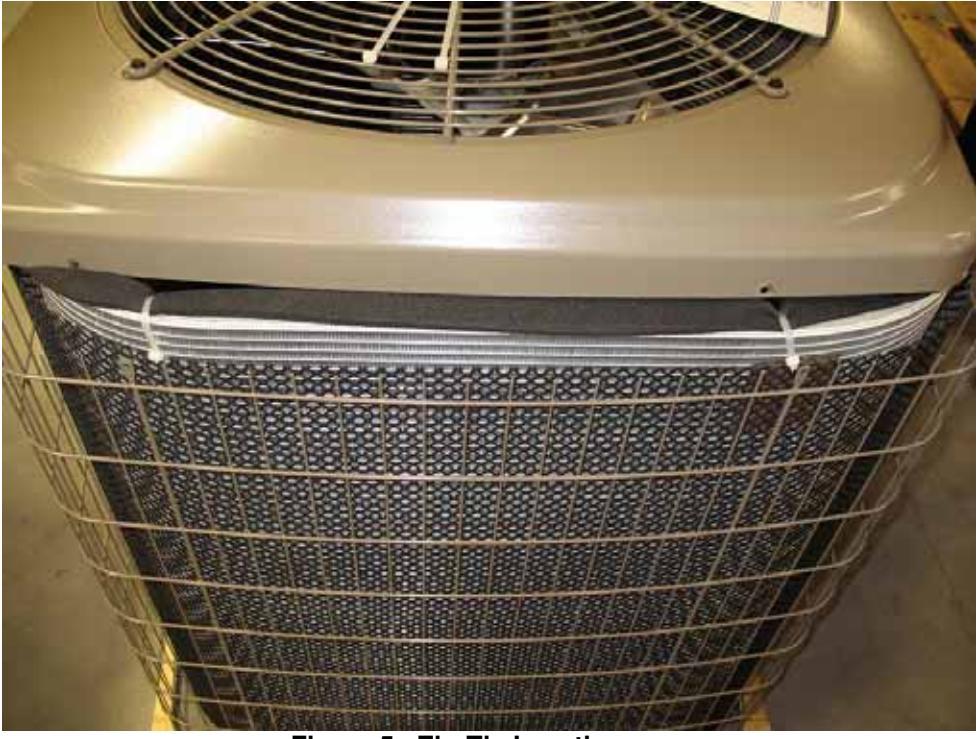
Figure 5: Zip-Tie Locations
