Parker Hannifin Corporation
Sporlan Division
206 Lange Drive
Washington, MO 63030 USA
Phone 636.239.1111
Fax 636.239.9130

July 29, 2014

SUBJECT: RESIDENTIAL AC & HP SYSTEM CONTAMINANTS AFFECTING TEV PERFORMANCE

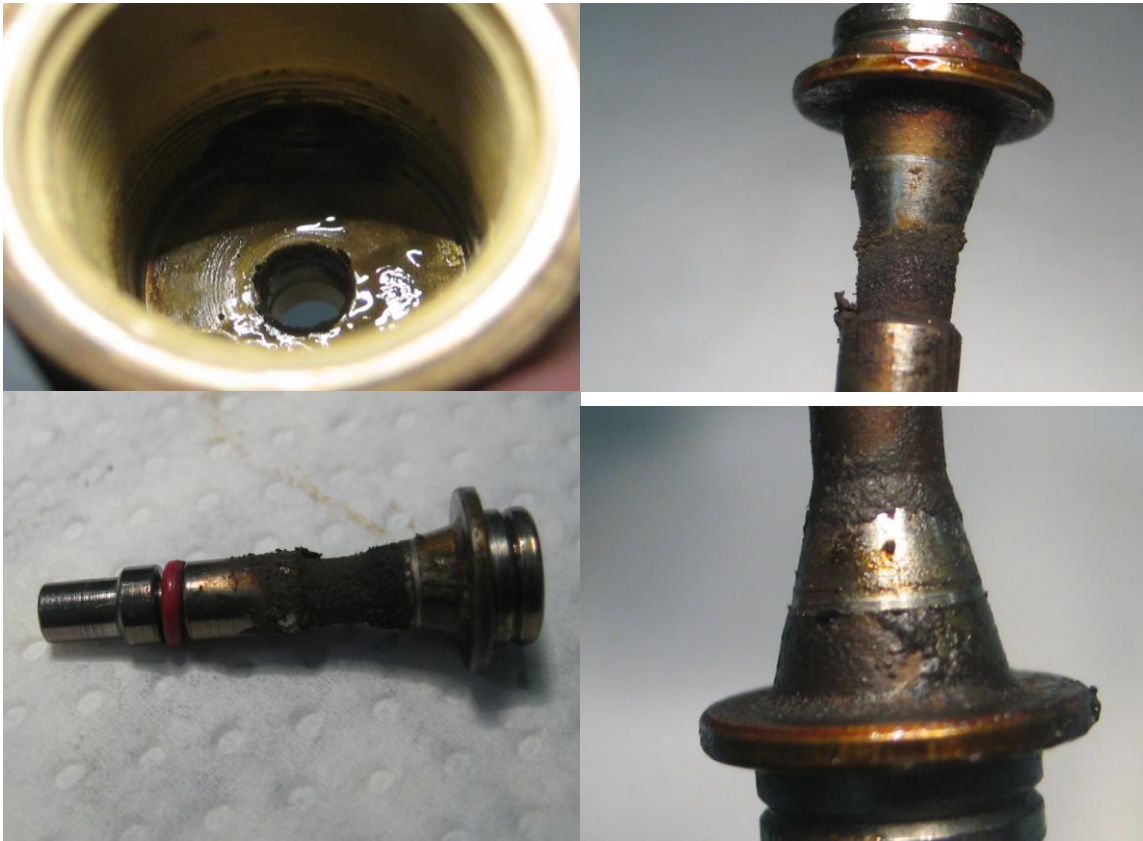
Sporlan Division of Parker-Hannifin has examined many returned valves in recent weeks and we find the same problem occurring throughout these returned valves. The valve has a brown or black resin-like material on the pin and the body that is stopping the valve from moving properly so it can maintain the proper superheat. Please see photos on page 2. Obviously, the material is not in the valve at the start-up of the system or the valve would not operate properly when the unit is put into service. The thermostatic expansion valve is actually not the problem; it is simply the location where this material collects.

Photos of valve body and pins from Various AC & HP Systems

There is no current proven method to capture this contamination before it reaches the valve. The industry standard cleanup procedures are the best recommendation since this is a contamination related issue. This procedure indicates the use of an oversized liquid line filter-drier and a suction line filter-drier. We cannot guarantee that this technique will solve the problem; it is simply the method that has solved most contamination issues in the past. Sporlan does not recommend attempting to clean TEVs in the field to eliminate this contamination.
