***Ducted Systems  
Technical Services  
Service Tips Letter***

Letter: **ST-009-2016**

Subject: **Application Engineering Observations on Errant Current Protection  
for Electric Motors in HVAC / Refrigeration Systems**

Product: Residential and/or Commercial products with Variable Frequency Drives (VFDs)

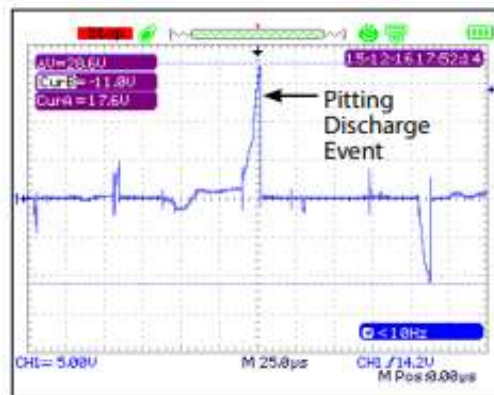
Figure 4. Source: AEGIS Bearing Protection Handbook, Edition 3 <https://www.est-aegis.com/index.php>

Note the switching speed of the drive represented in Figure 4 is 20 kHz. This means the switching by the IGBTs are running at 20,000 times per second. (AC is 60 cy per second for reference.) Every time they switch they arc.
